**SILICIDE COATINGS FOR TANTALUM  
AND COLUMBIUM ALLOYS**

H.E. Shoemaker and A.R. Stetson

**NATIONAL AERONAUTICS AND SPACE ADMINISTRATION**

CONTRACT NAS3 — 9412

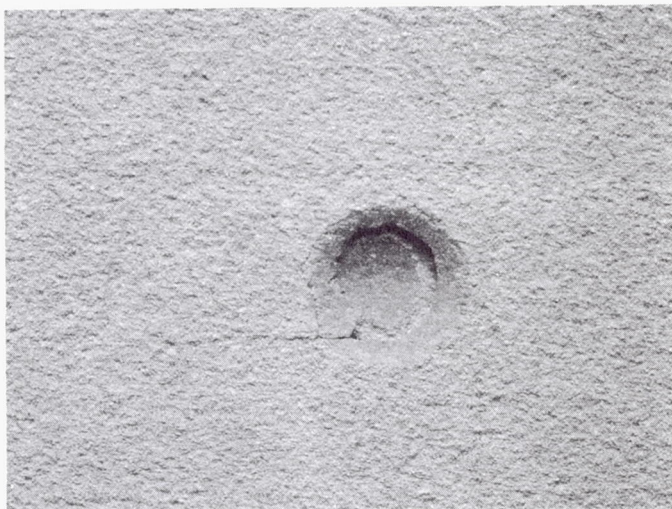
NS-1  
Impact Side  
(Typical of all 10 coatings  
except NS-5)

NS-1  
Back Side  
(Typical of all 10 coatings)

FIGURE 31. SPECIMENS AFTER INITIAL ROOM TEMPERATURE IMPACT  
AT CONDITION 1 (0.44 gm ball at  $170 \pm 15$  ft/sec)

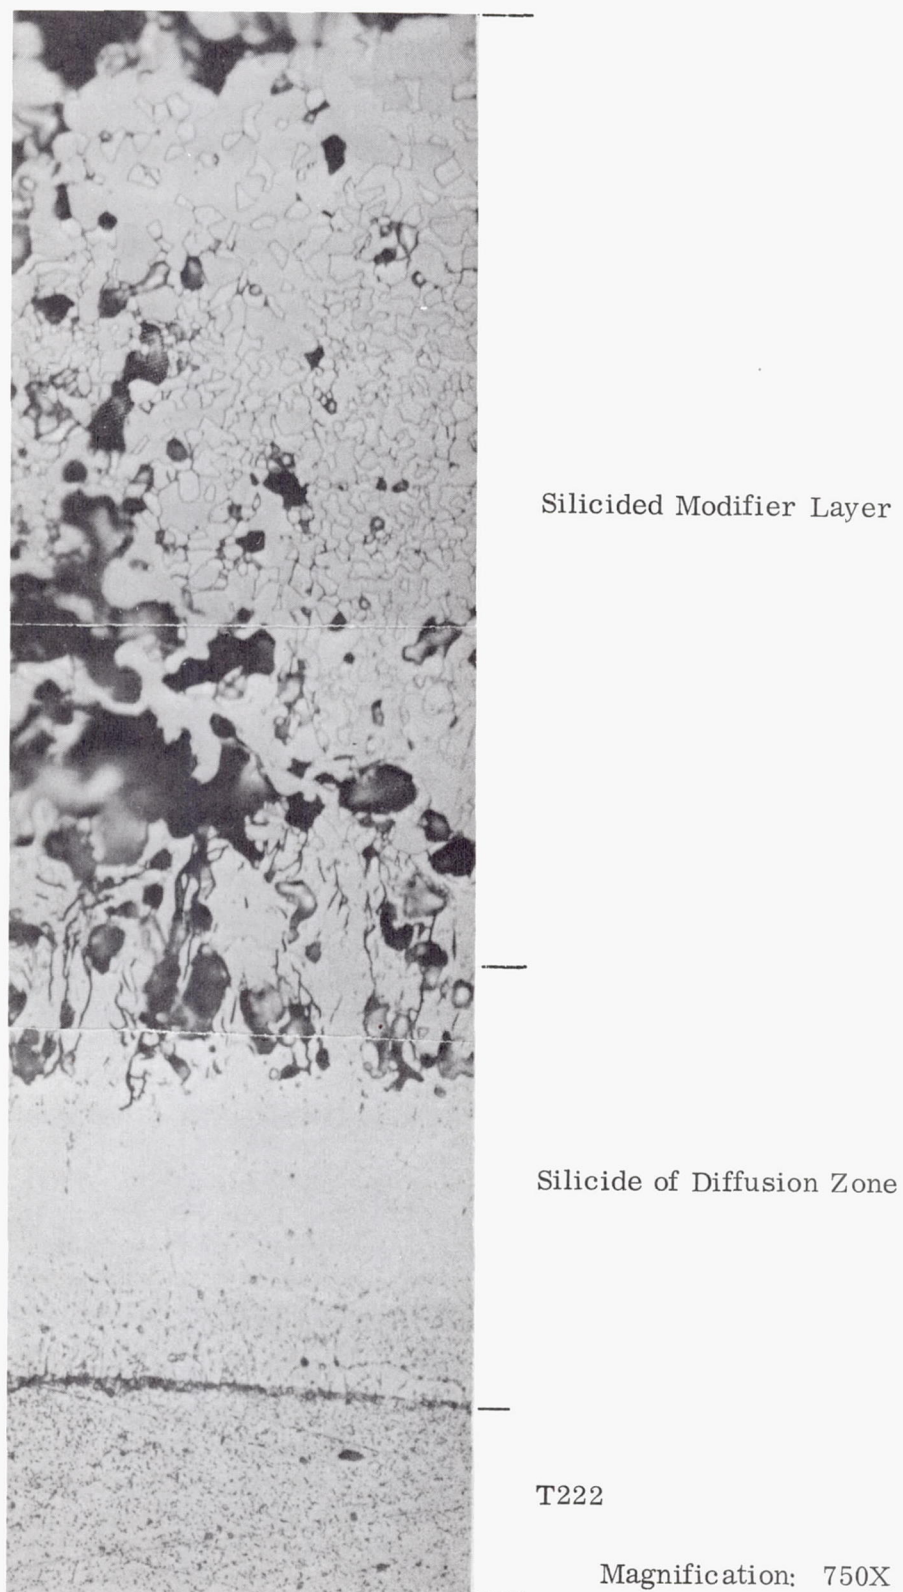
FIGURE 51. NS-3 COATED T222 AFTER 800 HOURS OF 2400°F CYCLIC OXIDATION
